# BEAR LAKE COUNTY AIRPORT (PARIS)

This report describes how your pavement maintenance management program was developed. This program was developed as part of the Network Pavement Management Program project sponsored by the Idaho Transportation Department, Division of Aeronautics. The information and data contained in this report ensures you are in compliance with the requirements of Federal Aviation Administration (FAA) Grant Assurance Number 11 which states that any airport requesting federal funds for pavement improvement projects must have implemented a pavement maintenance management program (PMMP).

Using the branch, section and sample unit divisions established, a visual condition survey was conducted at Bear Lake County Airport (Paris) on November 04, 2006. During the inspection pavement defects were identified and measured in accordance with the methodology outlined in FAA AC:150/5380-6 and ASTM D5430. Our inspection ensures your airport complies with the “detailed inspection” requirement of FAA’s PMMP guidelines. After collection, the data were entered into the Micro PAVER software for analysis. These data are reproduced in the Re-Inspection Report attached in Appendix 2

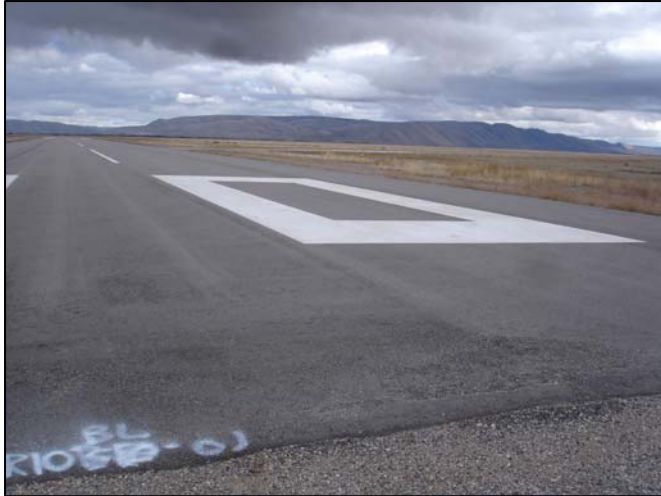
Sample Number: 01 Type: R Area: 5,625.00SqFt PCI = 86  
48 LONGITUDINAL/TRANSVERSE CRACKING L 145.04 Ft  
52 WEATHERING/RAVELING M 15.00 SqFt

Sample Number: 03 Type: R Area: 5,625.00SqFt PCI = 96  
48 LONGITUDINAL/TRANSVERSE CRACKING L 23.01 Ft

Sample Number: 12 Type: R Area: 5,625.00SqFt PCI = 93  
48 LONGITUDINAL/TRANSVERSE CRACKING L 112.03 Ft

Sample Number: 31 Type: R Area: 5,625.00SqFt PCI = 87  
48 LONGITUDINAL/TRANSVERSE CRACKING L 131.03 Ft  
55 SLIPPAGE CRACKING N 15.00 SqFt

Sample Number: 45 Type: R Area: 5,625.00SqFt PCI = 95  
48 LONGITUDINAL/TRANSVERSE CRACKING L 61.02 Ft

Sample Number: 59 Type: R Area: 5,625.00SqFt PCI = 90  
48 LONGITUDINAL/TRANSVERSE CRACKING L 162.04 Ft

Sample Number: 73 Type: R Area: 5,625.00SqFt PCI = 89  
48 LONGITUDINAL/TRANSVERSE CRACKING L 194.05 Ft

Section: R10BL-01  
Longitudinal/Transverse Cracking

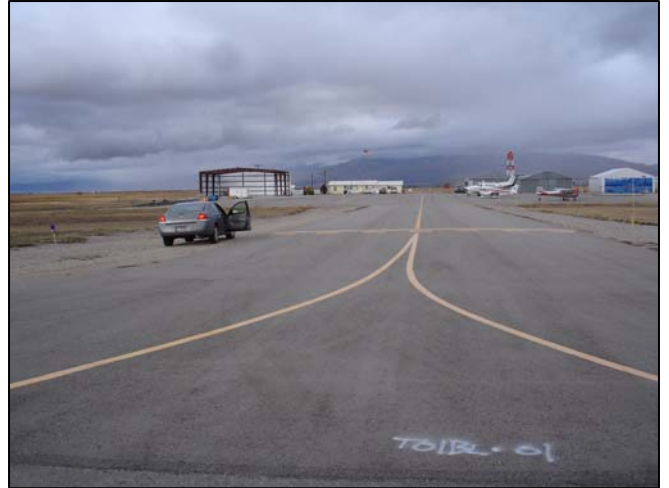
Sample Number:	01	Type:	R	Area:	4,686.00SqFt	PCI = 93
48	LONGITUDINAL/TRANSVERSE	CRACKING	L	78.02	Ft	
Sample Number:	02	Type:	R	Area:	4,000.00SqFt	PCI = 92
48	LONGITUDINAL/TRANSVERSE	CRACKING	L	84.02	Ft	
Sample Number:	03	Type:	R	Area:	4,004.00SqFt	PCI = 90
48	LONGITUDINAL/TRANSVERSE	CRACKING	L	121.03	Ft

Section: T01BL-01  
Longitudinal/Transverse Cracking

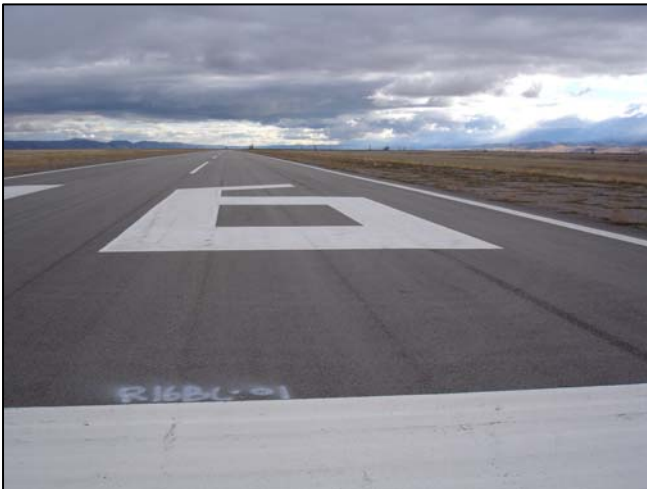
Sample Number:	02	Type:	R	Area:	6,000.00SqFt	PCI = 96
48	LONGITUDINAL/TRANSVERSE	CRACKING	L	33.01	Ft	
Sample Number:	08	Type:	R	Area:	6,000.00SqFt	PCI = 94
48	LONGITUDINAL/TRANSVERSE	CRACKING	L	88.02	Ft	
Sample Number:	14	Type:	R	Area:	6,000.00SqFt	PCI = 98
48	LONGITUDINAL/TRANSVERSE	CRACKING	L	6.00	Ft	
Sample Number:	20	Type:	R	Area:	6,000.00SqFt	PCI = 96
48	LONGITUDINAL/TRANSVERSE	CRACKING	L	20.01	Ft	
Sample Number:	26	Type:	R	Area:	6,000.00SqFt	PCI = 96
48	LONGITUDINAL/TRANSVERSE	CRACKING	L	23.01	Ft

Section: R16BL-01  
Longitudinal/Transverse Cracking

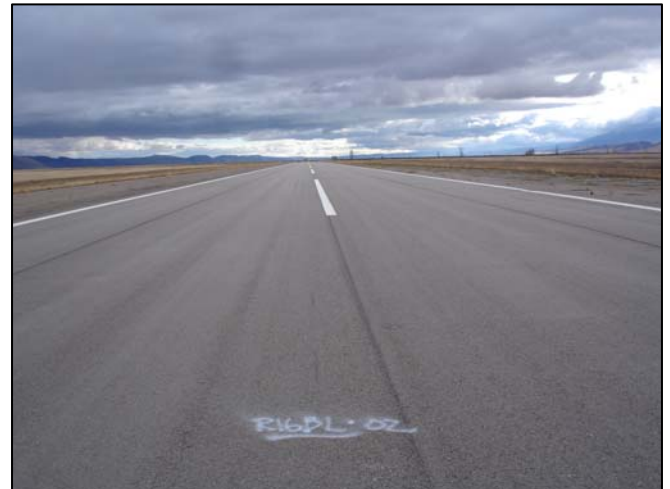
Sample Number:	01	Type:	R	Area:	6,000.00SqFt	PCI = 97
48	LONGITUDINAL/TRANSVERSE	CRACKING		L	8.00 Ft	
Sample Number:	07	Type:	R	Area:	6,000.00SqFt	PCI = 96
48	LONGITUDINAL/TRANSVERSE	CRACKING		L	23.01 Ft	
Sample Number:	13	Type:	R	Area:	6,000.00SqFt	PCI = 94
48	LONGITUDINAL/TRANSVERSE	CRACKING		L	95.02 Ft	
Sample Number:	19	Type:	R	Area:	6,000.00SqFt	PCI = 95
48	LONGITUDINAL/TRANSVERSE	CRACKING		L	59.02 Ft	
Sample Number:	21	Type:	R	Area:	6,000.00SqFt	PCI = 95
48	LONGITUDINAL/TRANSVERSE	CRACKING		L	50.01 Ft

Section: R16BL-02  
Longitudinal/Transverse Cracking

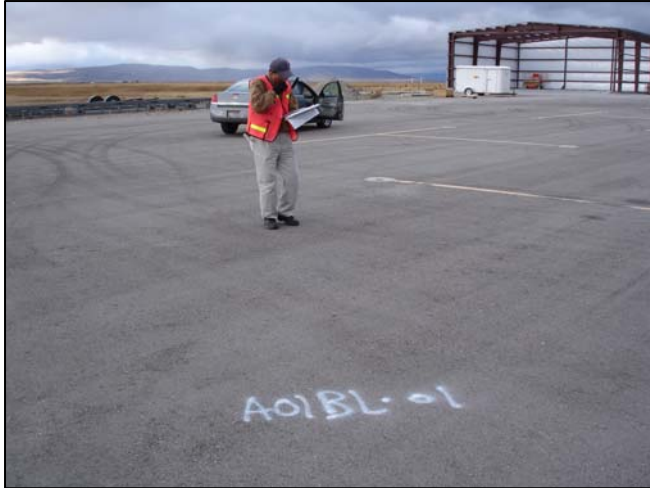
Sample Number: 01 Type: R Area: 4,100.00SqFt PCI = 92  
48 LONGITUDINAL/TRANSVERSE CRACKING L 94.02 Ft

Sample Number: 02 Type: R Area: 4,510.00SqFt PCI = 88  
48 LONGITUDINAL/TRANSVERSE CRACKING L 62.02 Ft  
55 SLIPPAGE CRACKING N 15.00 SqFt

Sample Number: 03 Type: R Area: 5,000.00SqFt PCI = 94  
48 LONGITUDINAL/TRANSVERSE CRACKING L 16.00 Ft  
49 OIL SPILLAGE N 10.00 SqFt

Sample Number: 04 Type: R Area: 5,000.00SqFt PCI = 96  
48 LONGITUDINAL/TRANSVERSE CRACKING L 20.01 Ft

Sample Number: 05 Type: R Area: 5,000.00SqFt PCI = 96  
48 LONGITUDINAL/TRANSVERSE CRACKING L 21.01 Ft

Section: A01BL-01  
Longitudinal/Transverse Cracking
